Protection Solutions

TPI Selector Switch

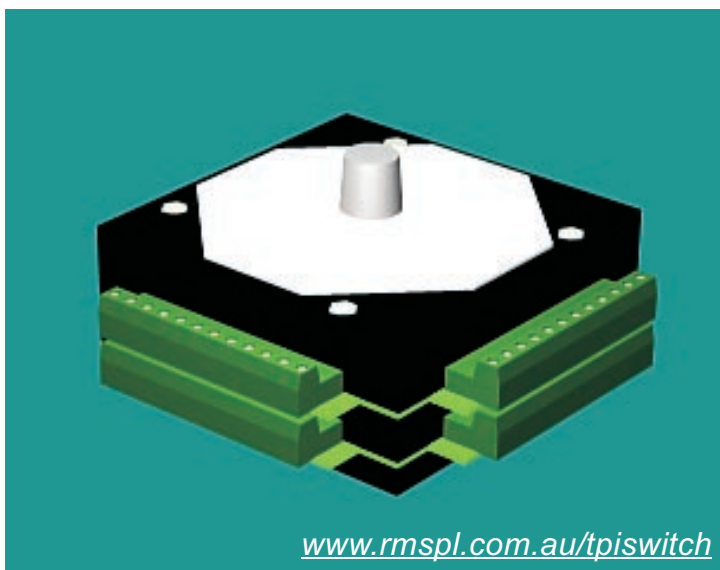
RMS has developed a custom rotary switch mechanism to replace old TPI switches. Gold plated low contact resistance switches are sealed in a specially machined case with connection via plug in Phoenix screw terminals. Two rows of contacts are provided for separate out of step and tap position indication. A different circuit board is designed for each tap changer based on the number of taps and angle between tap positions. Mounting brackets and drive shaft adaptors to suit specific tap changers completes the upgrade kit.

The tap position indicator (TPI) switch, found on many old power transformer on load tap changers, requires a high wetting current to provide reliable operation. Even at high current levels the TPI switch may go open circuit causing loss of control and out of step alarms. This problem is made even worse when a modern voltage transducer is fitted due to limitations in the current source used to power to the resistor string.
